**WASHINGTON COUNTY
BOARD OF EDUCATION**

Re: Proposal for Washington County Schools Assessment
Washington County, TN

Dickson Elementary School
Facility Assessment Observations

Rush Strong School
Facility Assessment Observations

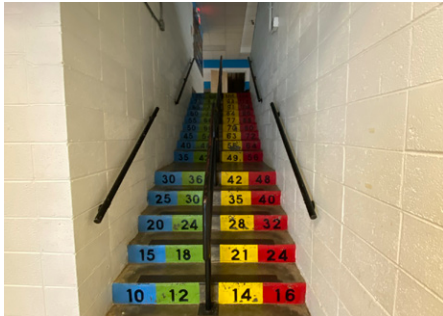
01 ADA non-compliant cafeteria and gym

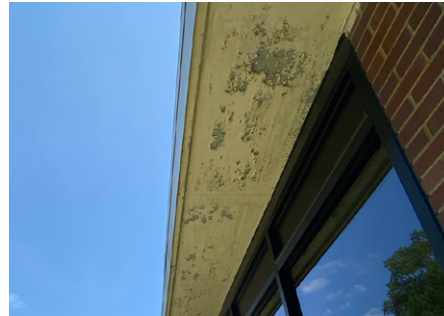
02 degrading soffit

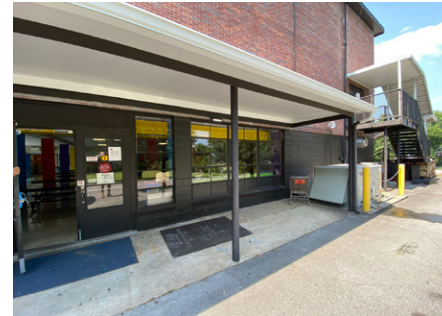
03 exterior finishes showing normal wear

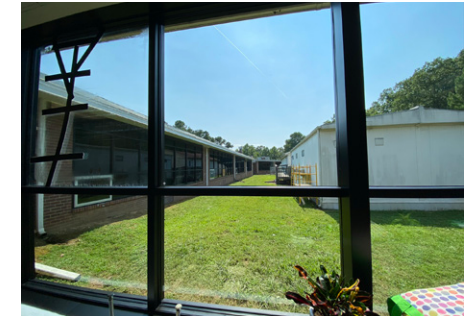
04 portables block views

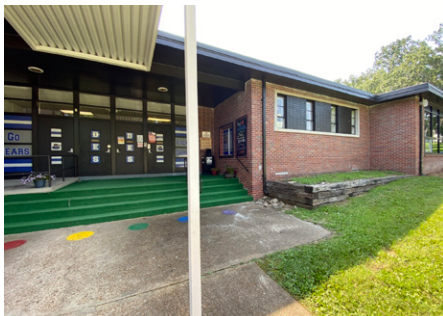
05 front entry is open and inviting; ADA access provided

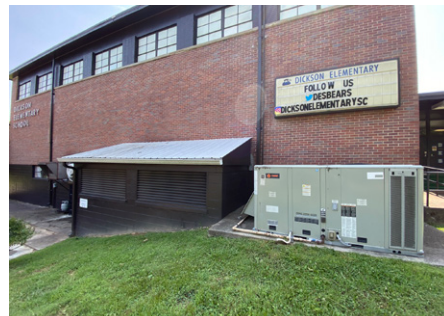
06 HVAC unit is exposed and within public view

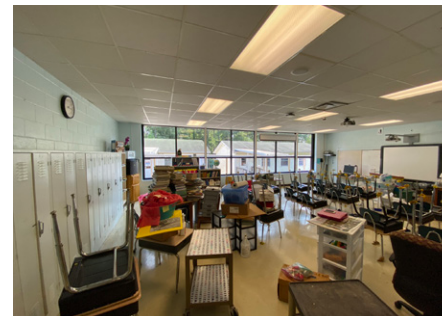
07 classrooms are cluttered and lacking adequate storage

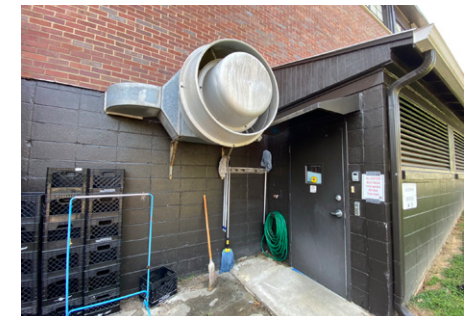
08 Fan unit is exposed and within public view

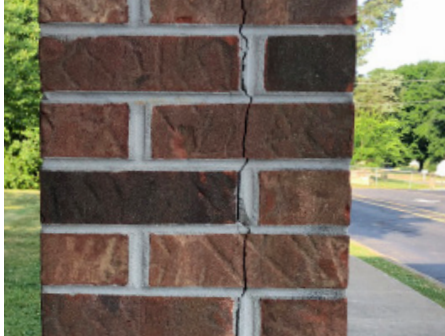
01 cracking brick

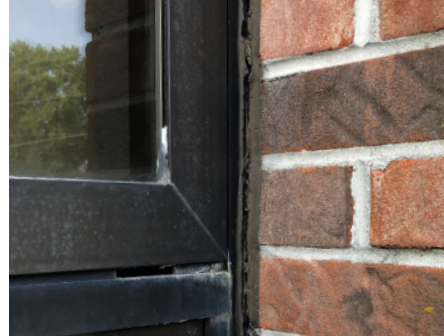
02 gap at window perimeter

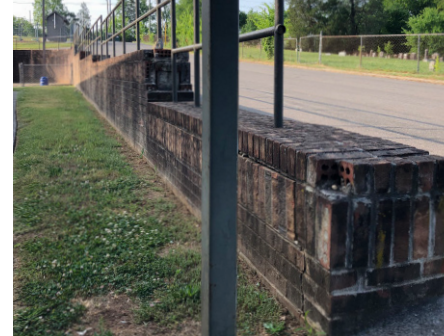
03 masonry deterioration

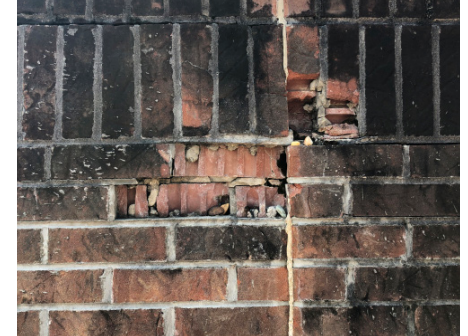
04 masonry deterioration

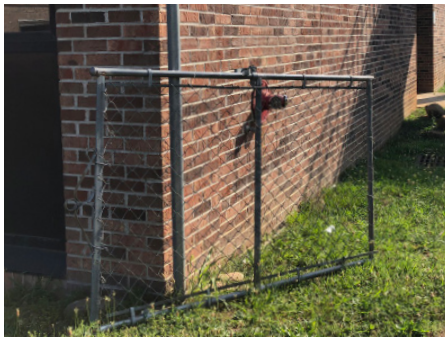
05 perimeter not secure;
gate off hinges

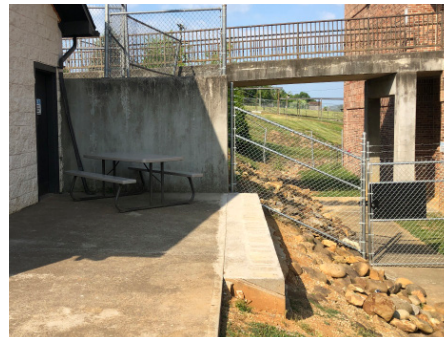
06 lack of safety barrier

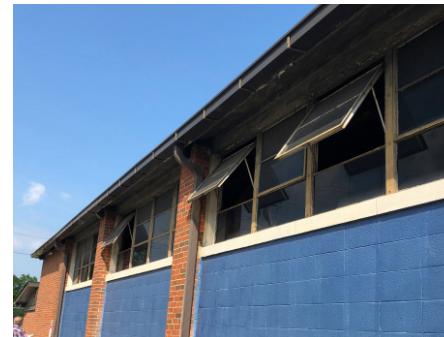
07 windows left open

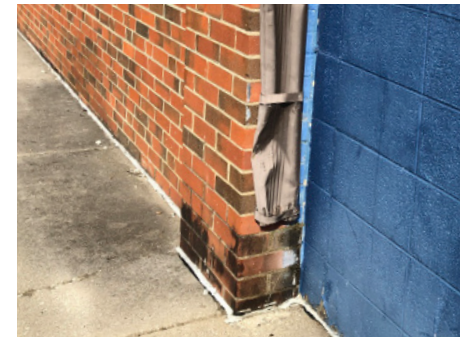
08 damaged downspout

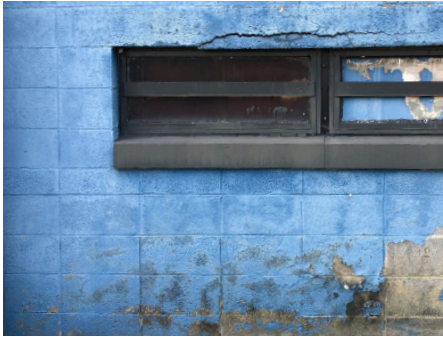
09 cracking masonry, peeling paint

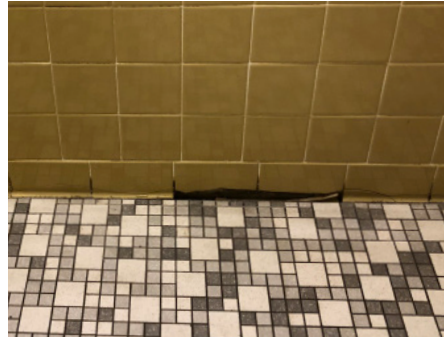
10 separation between wall and floor slab *

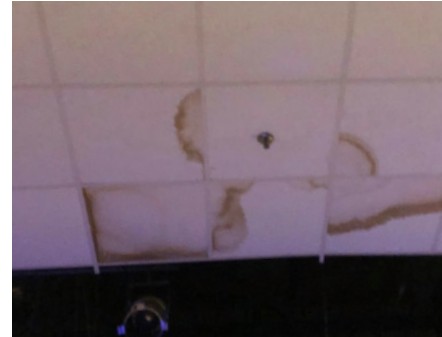
11 stains in ceiling tile

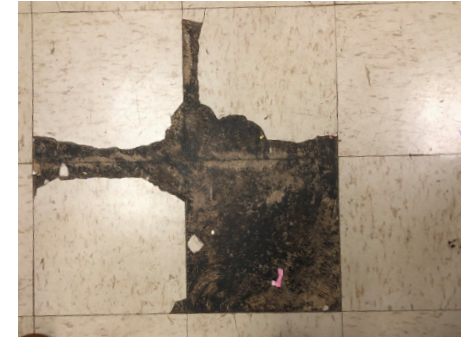
12 deterioration in VCT

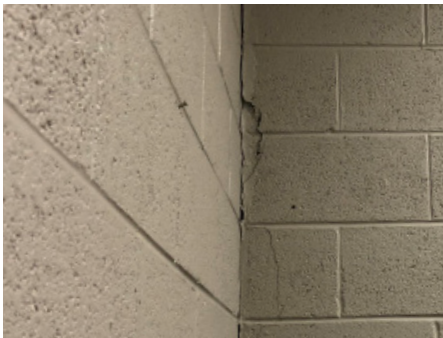
13 separation/crack between walls *

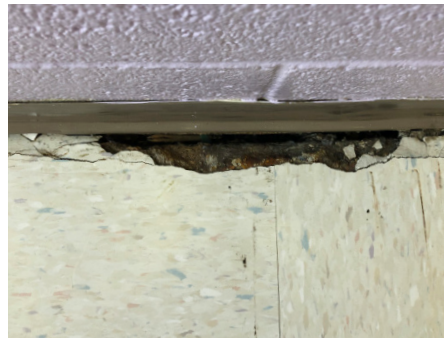
14 separation between wall and floor slab *
