**WASHINGTON COUNTY
BOARD OF EDUCATION**

Re: Proposal for Washington County Schools Assessment
Washington County, TN

Dickson Elementary School
Facility Assessment Observations

Rush Strong School
Facility Assessment Observations

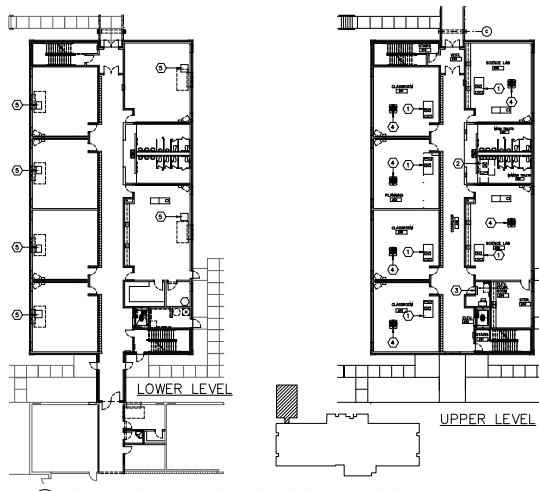
RUSH STRONG ADDITION FLOOR PLAN – LEVELS 1 & 2 – HVAC
SCALE: NONE

1. Some units do not have duct mounted smoke detector in both the supply and return ducts.
